# ALDBURY PARISH COUNCIL      WARDENS UPDATE: JUNE 2024

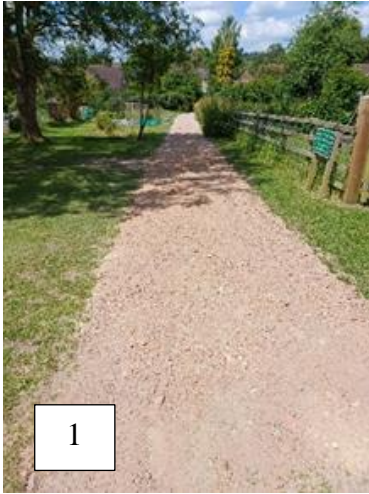
<b>AREA</b>	<b>ALLOTMENTS &amp; MILLENNIUM ORCHARD</b>
<b>TO CHECK</b>	Fencing & gates, benches, trees, hedges & shrubs, grass height, signs, footpaths, housekeeping, ground conditions
<b>INSPECTION DATES</b>	31/05, 7/06, 14/06, 21/06
<b>ISSUES TO REPORT</b>	<ol style="list-style-type: none"> <li>1. No notable defects were found on fences, gates, and benches.</li> <li>2. Grass has been regularly mown in accordance with the mowing specification.</li> <li>3. Public footpaths were well defined. Waymarkers were in place.</li> <li>4. Good housekeeping was evident, and most plots continue to be well tended..</li> <li>5. An upgraded access track has been laid (Photo 1).</li> </ol>

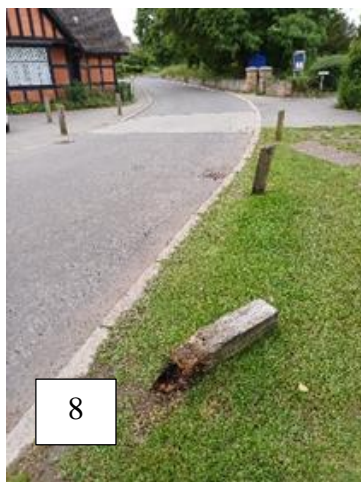
<b>AREA</b>	<b>VILLAGE GREEN(S) &amp; POND</b>
<b>TO CHECK</b>	Benches, Trees, Pond, Grass height, Stocks, Litter Bins, Notice board.
<b>DATES</b>	31/05, 7/06, 14/06, 21/06
<b>ISSUES TO REPORT</b>	<p>19. All benches were seen in fair condition.</p> <p>20. Trees were found in a sound condition. Some dead wood has been shed and lying on the ground. No broken branches were visible on the trees.</p> <p>21. Grass was meeting the mowing specification. Favourable public feedback continues to be voiced about the renovated pond and neat surrounds.</p> <p>22. Weekly litter picking was carried out.</p> <p>23. Litter bins are in place and found in reasonable condition.</p> <p>24. Parish notice board information continues to be current, relevant, and well presented.</p> <p>25. A wooden post has toppled on the village green (Photo 8). Clerk aware. This will be replaced after filming.</p>
